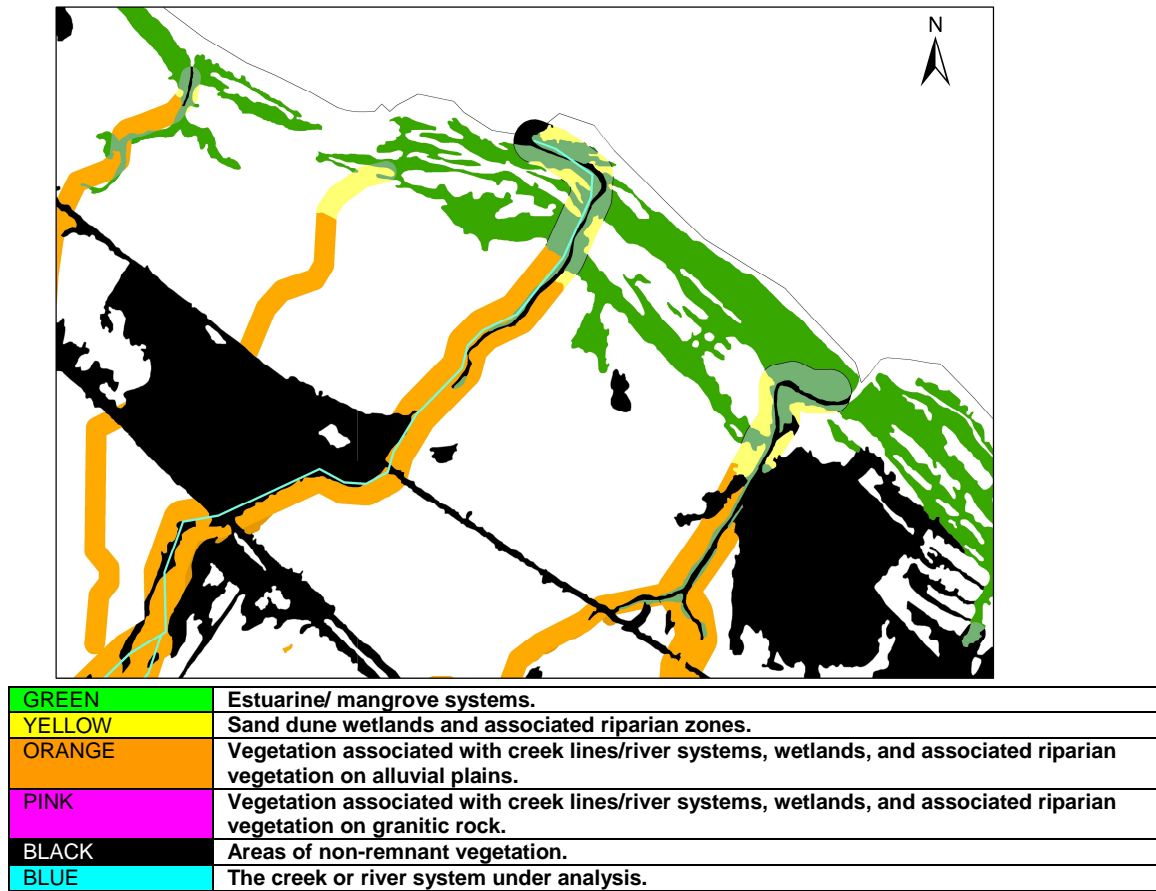
Figure 56: Riparian Systems of Leichardt Creek Lower Reaches

The riparian condition of Leichardt Creek's lower reaches is generally moderate. However, disturbances between the Bruce Highway and the railway corridor are extensive with the northern bank completely cleared between these two corridors. This land has been used for agricultural/pastoral purposes with exposed surfaces potentially compromising water quality via overland flows. All other areas have extensive coverage with only minor disturbances within the designated buffer zone.
