# Assessment of Selected Riparian Systems of the Ross and Black River Basins Townsville / Thuringowa Region

Report prepared for Creek to Coral

June 2007

CLIENT: CREEK TO CORAL  
PROJECT: RIPARIAN ASSESSMENT OF THE ROSS AND BLACK RIVER BASINS  
REPORT: RIPARIAN ASSESSMENT  
REF: C2C RA 07

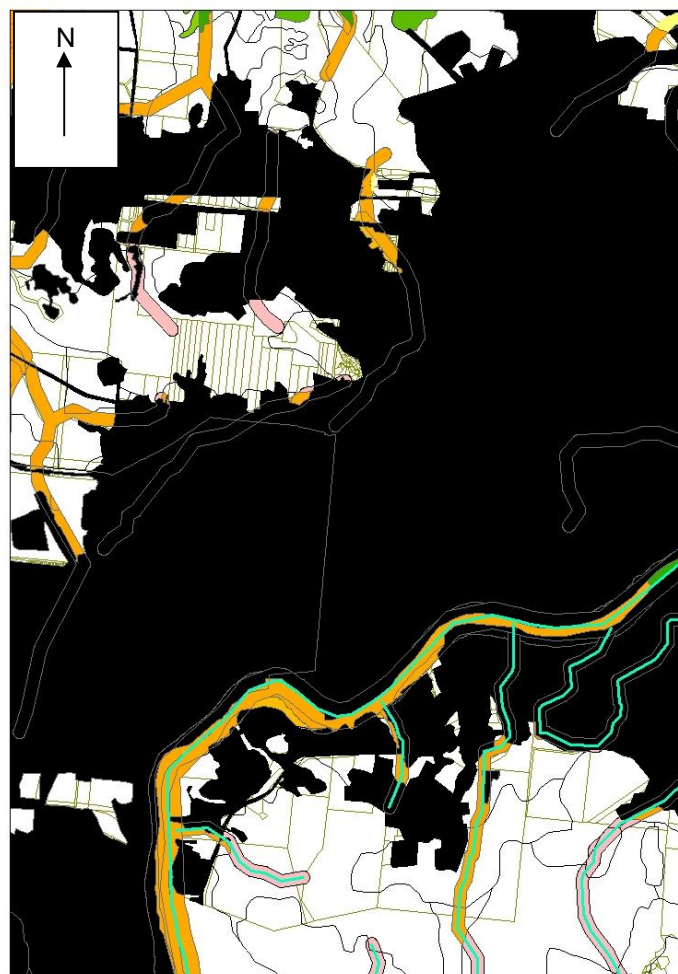
**Figure 11: Riparian Systems of the Middle Reaches of Ross River, Black Weir to Aplins Weir .**

Large areas within this reach have been mapped as non-remnant. However, the condition of this non-remnant riparian zone is quite good. This is mainly the area from Black to Aplins Weir, which, although having a highly modified riparian condition is still functioning as a buffer system for **localised** overland flows. These areas are also highly modified with para grass providing habitat for wading birds and frogs, including *Litoria falax*, *Litoria rubella*, *Litoria rothii*, *Litoria gracilentia* and *Litoria inferfrinata* (*Litoria inferfrinata* is only found locally within the para grass of the Bush Garden near Aplins Weir). The first and second order streams flowing in from Annandale are highly modified. However these areas have recently been upgraded with grassed slopes and native vegetation.

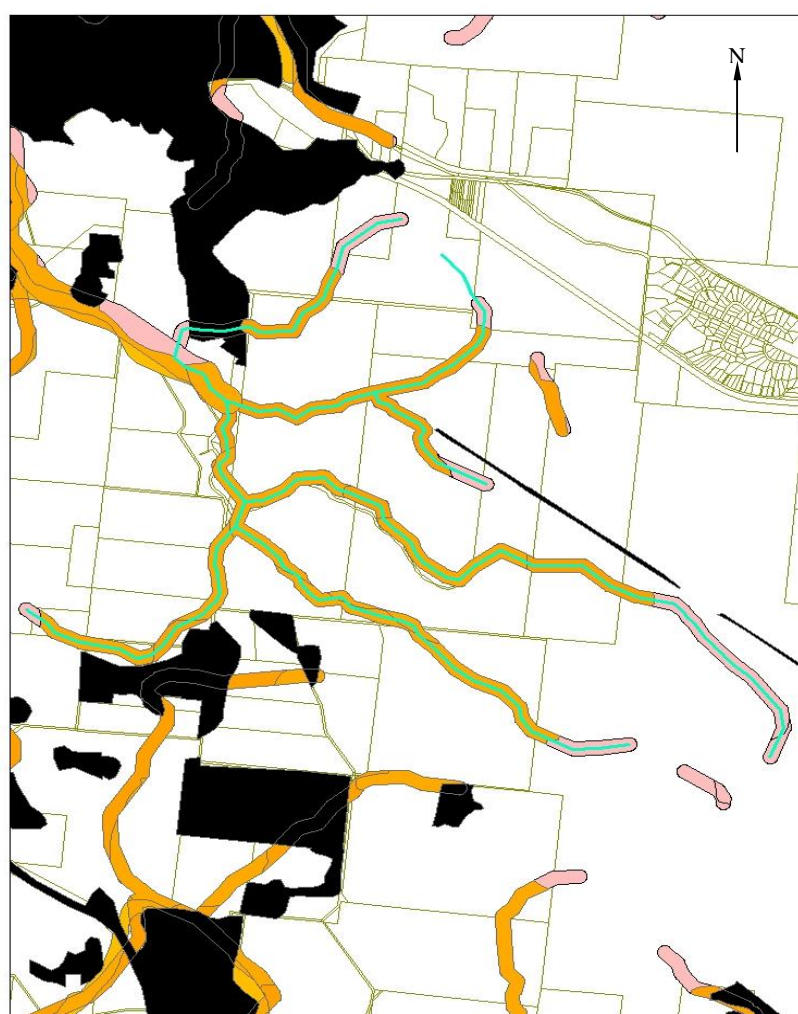
**Figure 15: The Riparian Systems of the Upper Reaches of Stuart Creek**

The upper reaches of Stuart Creek are in an almost pristine condition with minimal disturbance within the designated buffer zones. Significant, non-designated, riparian zones are also present within the upper reaches of the creek. Only small sections of non-remnant vegetation exist within the 75m buffer zone of the most northerly 1st order creek.

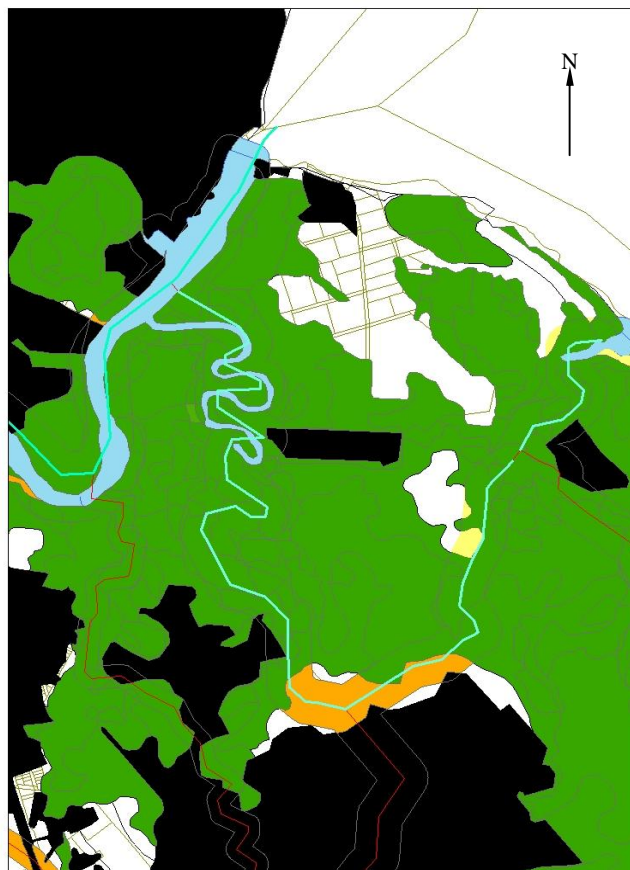
**Figure 17: Riparian Systems of the Lower Sections of Stuart Creek**

Although no remnant riparian buffer zones exist within 150m of a third to fourth order stream in the lower section of Stuart Creek, the estuarine sections of the creek are in pristine condition with no disturbance within the designated buffer zones. Significant, designated, riparian zones extend well outside the buffer width of 150m with a moderate degree of connectivity to the estuarine systems of Ross River. The surrounding creek areas are a perfect representation of a mangrove marine sequence with mixed mangrove forest zoning into a marine couch grassland and finally a samphire clay plain. The riparian value of this sequence can not be understated, offering significant buffering capacity for overland flows and high ecological and habitat values. Further the distributaries of Stuart Creek offer the last remaining access paths for catadromous and anadromous fishes. All other flow pathways between the marine waters of Cleveland Bay and the fresh waters of the upper river systems have been cut by dams, weirs, or other infrastructure.

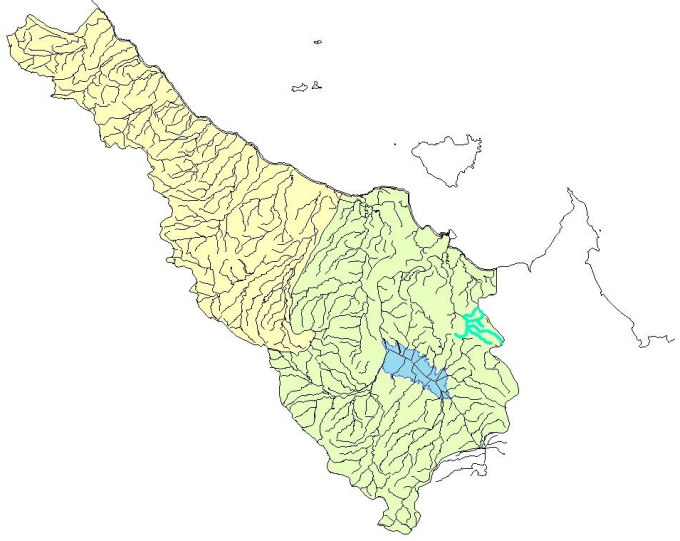
<p>Almost pristine condition with minimal disturbance within the buffer zones. Significant non-designated riparian zones present. Only minor area of non-remnant vegetation in the 75m buffer zone on the most northerly 1st order creek.</p>
<p>Lower Reaches</p>

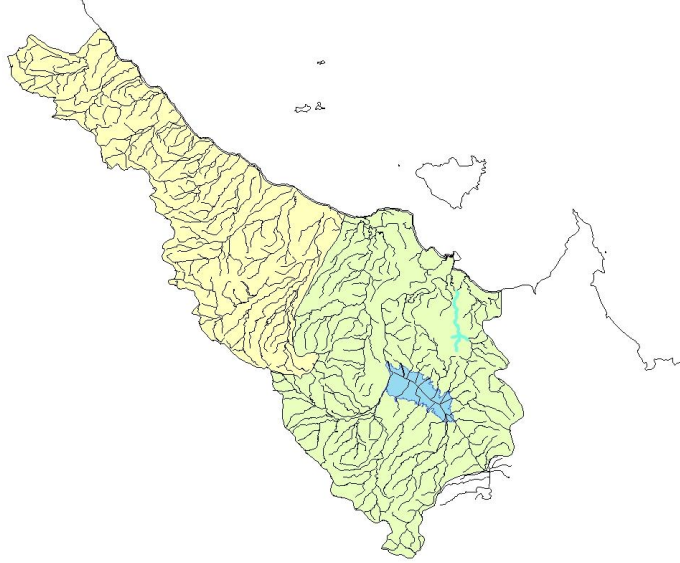
<p>Highly modified with a significant amount of disturbance and run off potential from non-remnant vegetation areas. May have problems from lack of riparian vegetation in areas where quarrying activities and industrial land uses are active. High levels of disturbance and potential sediment erosion from quarrying activities in areas with little, to no, buffering capacity.</p>

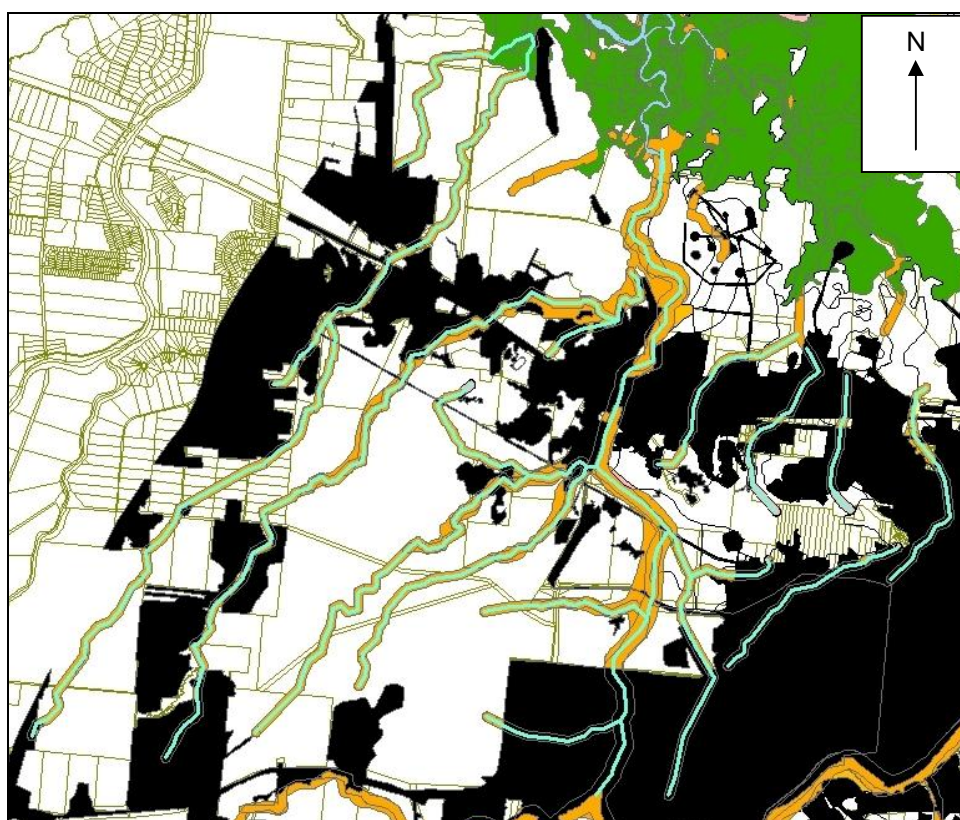
**Figure 20: Riparian Systems of the Middle Reaches of the Bohle River Catchment**

The Middle Section of the Bohle River catchment is highly modified with significant reaches of both 1<sup>st</sup>/2<sup>nd</sup> order streams and 3<sup>rd</sup>/4<sup>th</sup> order rivers having little to no remnant riparian vegetation. These include significant stretches of 3<sup>rd</sup>/4<sup>th</sup> order streams directly adjacent to areas that are used for cattle grazing. It also includes a complex system of 1<sup>st</sup> and 2<sup>nd</sup> order streams within the Bohle Industrial Area and adjacent to Louisa Creek, with no recognised riparian vegetation. Significant para grass infestations do occur within these areas, offering some bank stability and habitat protection.

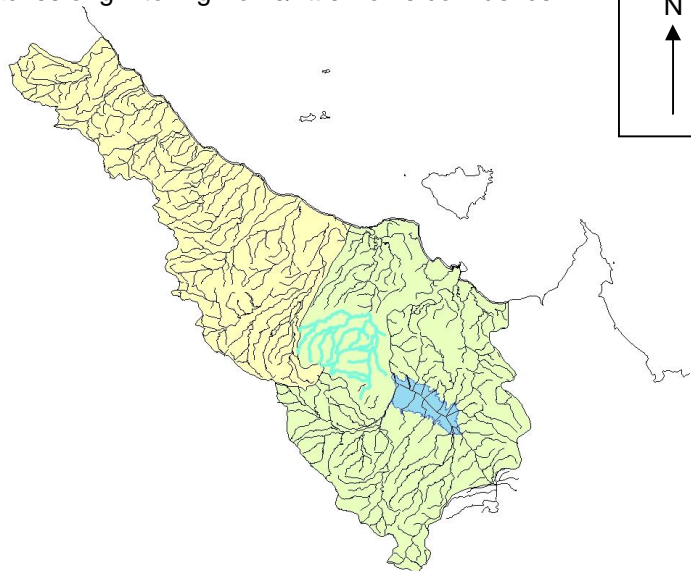
<p>The 1<sup>st</sup> and 2<sup>nd</sup> order streams in the upper reaches are generally in poor condition with little to no remnant vegetation cover. Areas are highly infested with chinee apple (<i>Ziziphus mauritiana</i>) and rubber vine (<i>Cryptostegia grandiflora</i>). While these plants are considered to have little to no riparian value, the protective value of the chinee apple to small birds has recently been attracting attention.</p> <p>Sodic and erodible soils are present within the area and overland flow across the unprotected soil profile may carry cause gullyng and the consequent transport of significant sediment loads into the channel.</p>
<p>Mid Reaches</p>

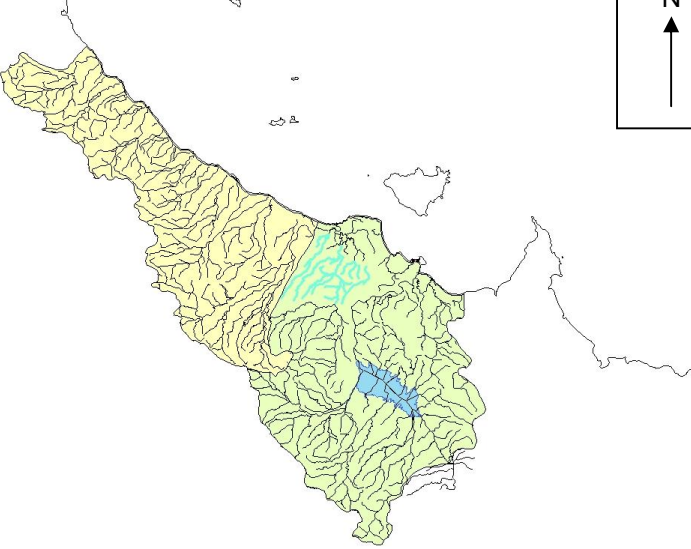
<p>Lower reaches have highly variable riparian condition with the Bohle Industrial Area and Louisa Creek catchment having a significantly modified riparian zone.</p>
